DEPARTMENT OF TRANSPORTATION**DIVISION OF ENGINEERING SERVICES**

Contract #: 04-0120F4Cty: SF/ALA Rte: 80 PM: 13.2/13.9File #: 69.28**WELDING INSPECTION REPORT****Resident Engineer:**Pursell, Gary**Address:** 333 Burma Road**City:** Oakland, CA 94607**Report No:** WIR-012404**Date Inspected:** 25-Feb-2010**Project Name:** SAS Superstructure**OSM Arrival Time:** 1900**Prime Contractor:** American Bridge/Fluor Enterprises, a JV**OSM Departure Time:** 700**Contractor:** Zhenhua Port Machinery Company, Ltd (ZPMC), Changxing Island **Location:** Shanghai, China**CWI Name:** See Below**CWI Present:** Yes No**Inspected CWI report:** Yes No N/A**Rod Oven in Use:** Yes No N/A**Electrode to specification:** Yes No N/A**Weld Procedures Followed:** Yes No N/A**Qualified Welders:** Yes No N/A**Verified Joint Fit-up:** Yes No N/A**Approved Drawings:** Yes No N/A**Approved WPS:** Yes No N/A**Delayed / Cancelled:** Yes No N/A**Bridge No:** 34-0006**Component:** OBG & Tower**Summary of Items Observed:**

OBG Bays 1 through 9

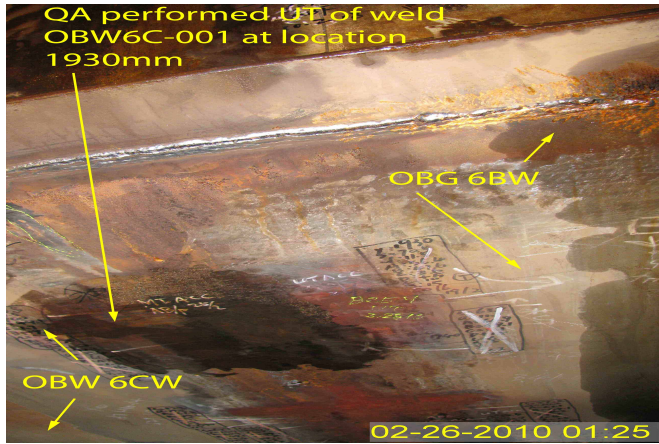
ABF issued "Inspection Notification Sheet" number 02242010-1 item #1 informing QA that at 1830 hours ABF Inspectors will be performing ultrasonic (UT) inspections of repaired weld OBW6C-001, 002 which joins the counterweight side plate of OBG segment 6BW to segment 6CW. This QA Inspector observed weld OBW6C-001, 002 have been marked by ABF ultrasonic inspectors as being UT accepted. This QA Inspector performed ultrasonic inspections at of weld OBW6C-001 at location 1930mm and weld OBW6C-002 at locations 680 and 785mm for detection of longitudinal and planar transverse indications utilizing scanning patterns A, B, C and D (AWS D1.5 Fig 6.7) and no UT rejections were observed. Items observed on this date appeared to generally comply with applicable contract documents. See the photograph below for additional information.
